Illinois Commerce Commission

Assessment of

South Beloit Water, Gas, and Electric Company's

Reliability Report and Reliability Performance

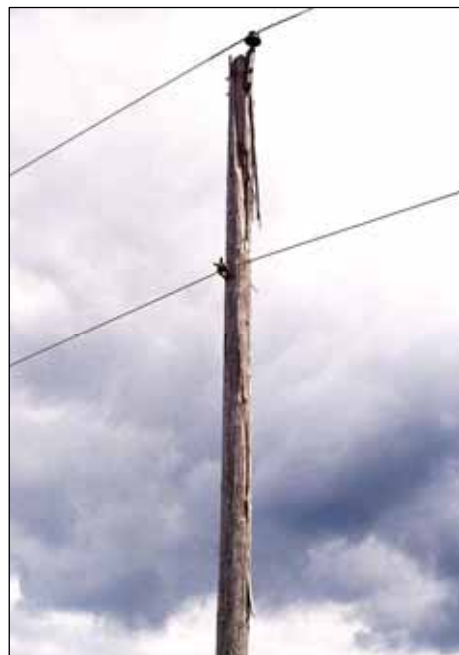
**Figure 2 (Photo 05M24)**  
**Lightning damaged pole top**  
**Circuit SHIJ54, Clover Rd. south of Yale Bridge Rd.**

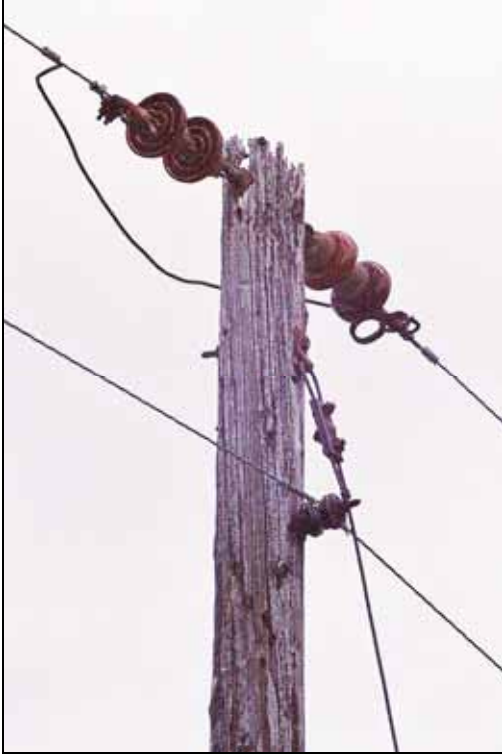
**Figure 3 (Photo 05M21)**  
Badly rotted pole & bad pole top  
Ckt. SHIJ54, Whitwer Rd. north of S. Bluff St.

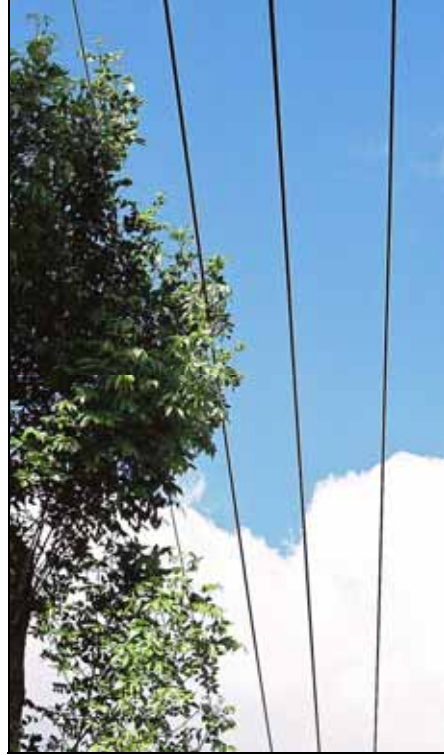
**Figure 4 (Photo 05M20)**  
Ash tree into primary  
Ckt. SHIJ54, Fischer Rd., South Beloit

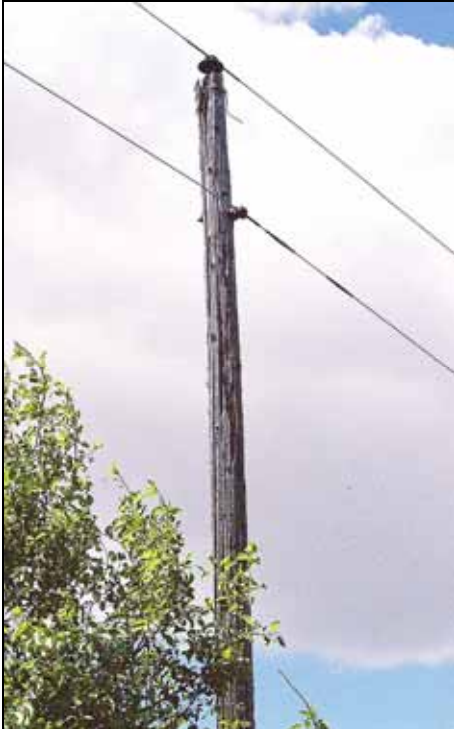
**Figure 5 (Photo 05M23)**  
Badly shell rotted pole, Circuit SHIJ54, Yale Bridge Rd. west of Whitwer Rd.

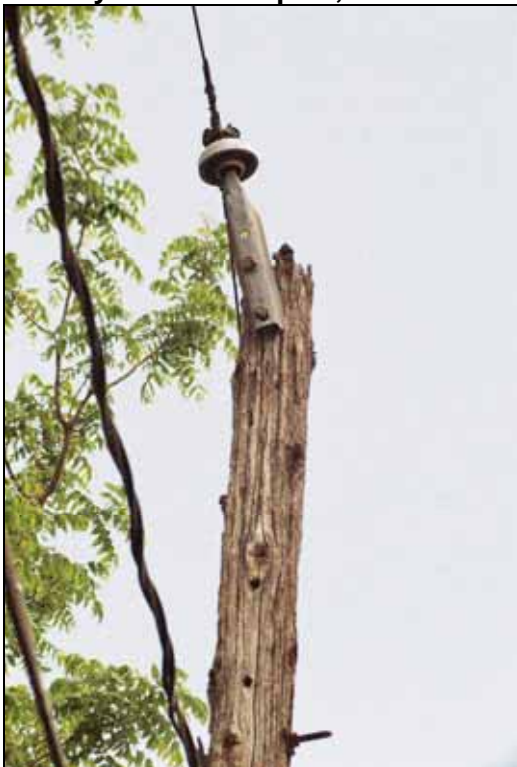
**Figure 8 (Photo 05N3)**

Badly shell rotted pole, Circuit SHWJ672, Whittmore Dr. southeast of Barbara

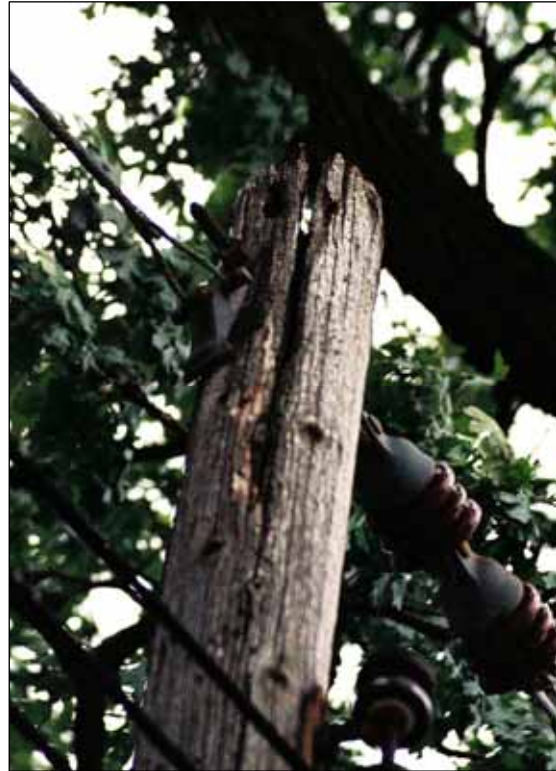
**Figure 10**  
Deteriorated & split pole top  
Circuit SHWJ672,  
Oak Grove Ave. west of Northwestern Ave.

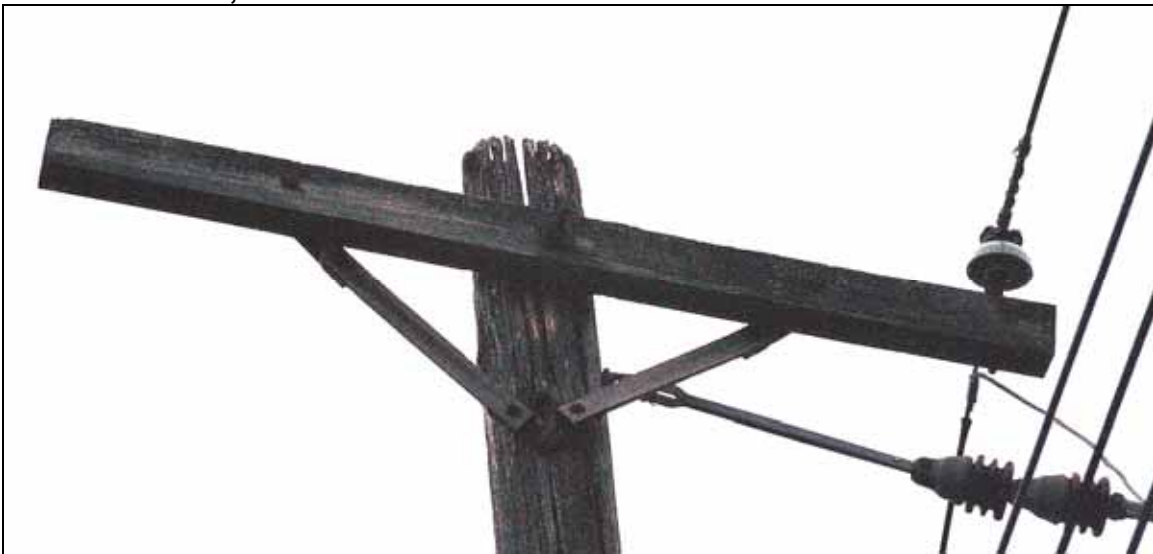
**Figure 11**  
Deteriorated & split pole top  
Circuit SHWJ672, Oak Grove Ave. at Fairview Ave.

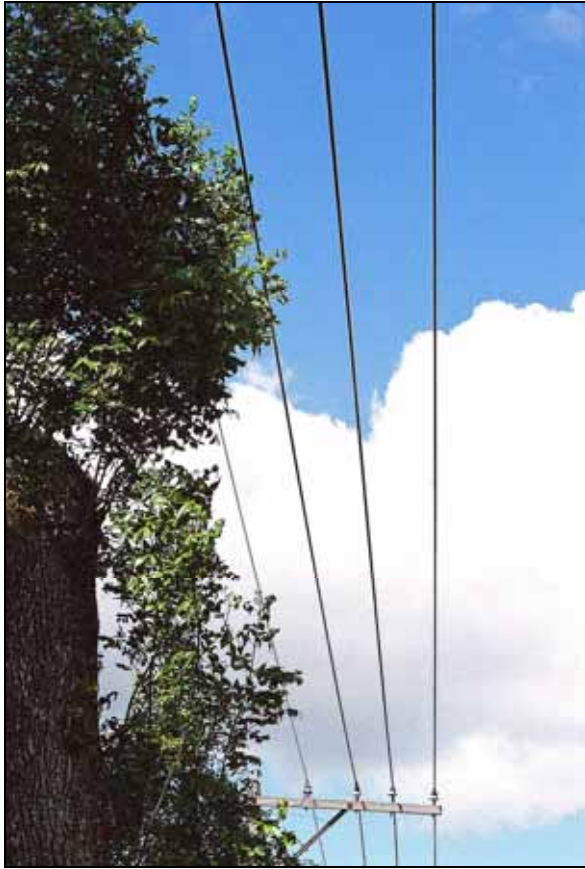
**Figure 1 (Photo 05M19)**  
**Ash tree into primary**  
**Fischer Rd., South Beloit**

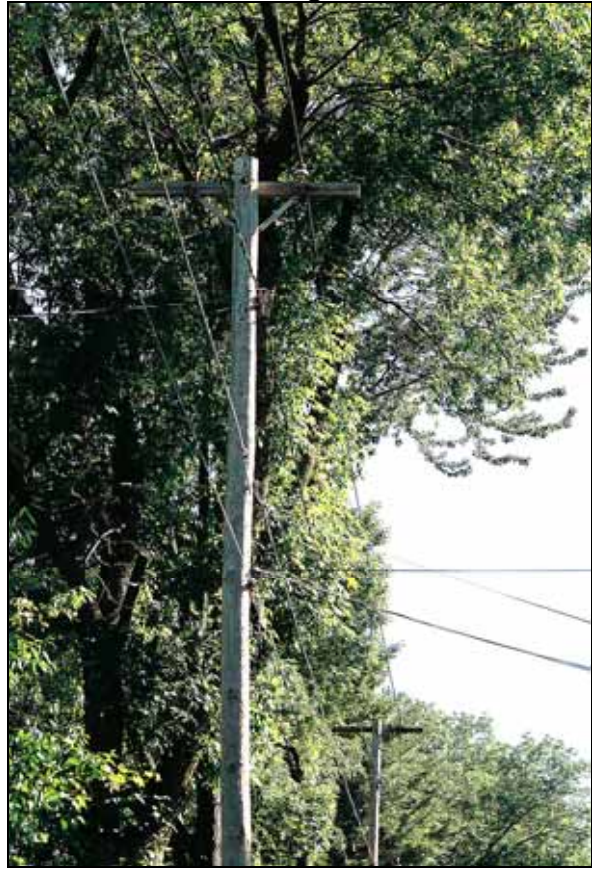
**Figure 2 (Photo 05N19)**  
**Hardwood (ash?) tree into primary**  
**Watts Ave. N. of Dingman Dr., Rockton**
